BATTERY POST ABUSE SAMPLES

"Titan only warrants that this Battery is free of defects in material and workmanship under normal use and service conditions and in terms of correct application." Thus using batteries for any other purpose than the correct application will void the warranty. Battery casing and Posts can give a good indication as to the use and abuse of the battery.

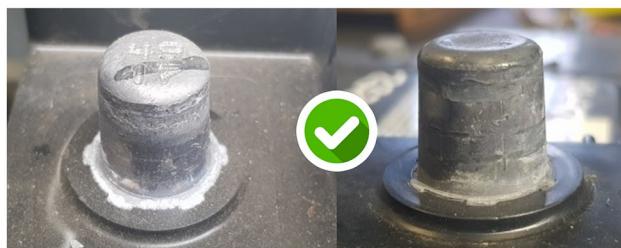
Examples of 2 year old battery post used only for automotive starting purposes.
